# Your survey report

18 Victoria Terrace, Dereham, Norfolk

MBS-2409-022

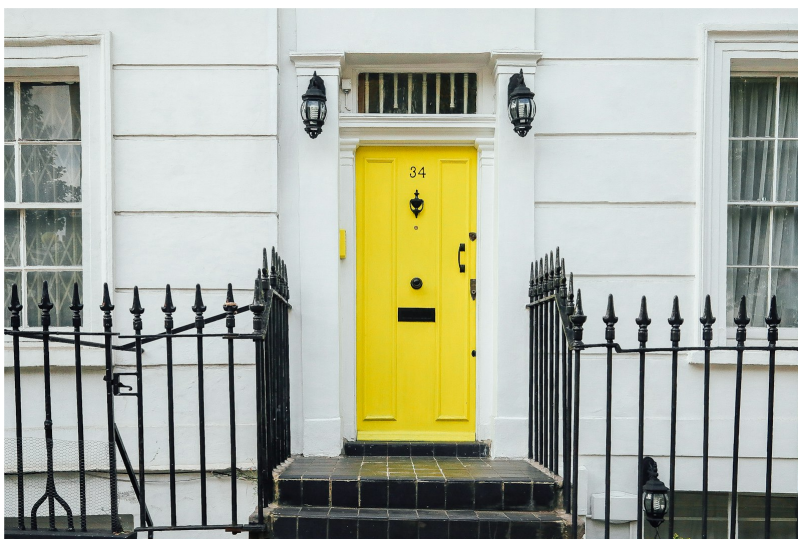
The front door is a composite unit and the rear door is uPVC. Both were in satisfactory condition.

*Front door*

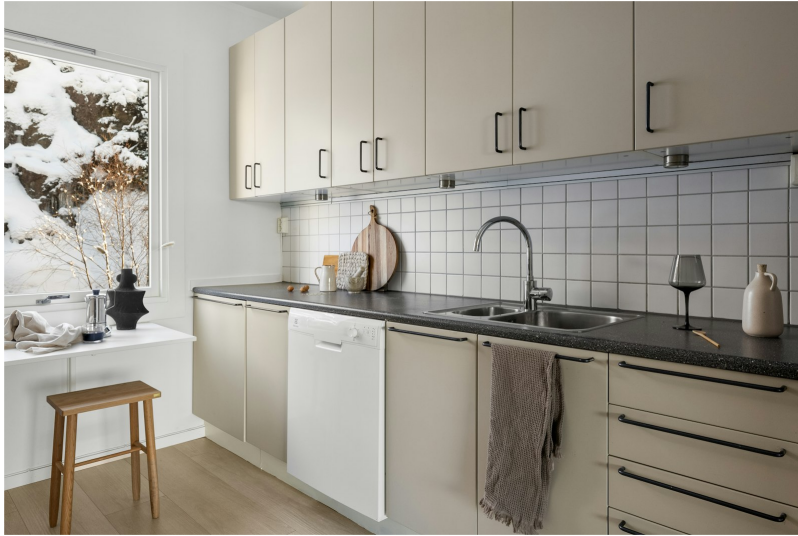
The kitchen fittings were installed around 2018 and are in good order.

*Kitchen, fitted c.2020*

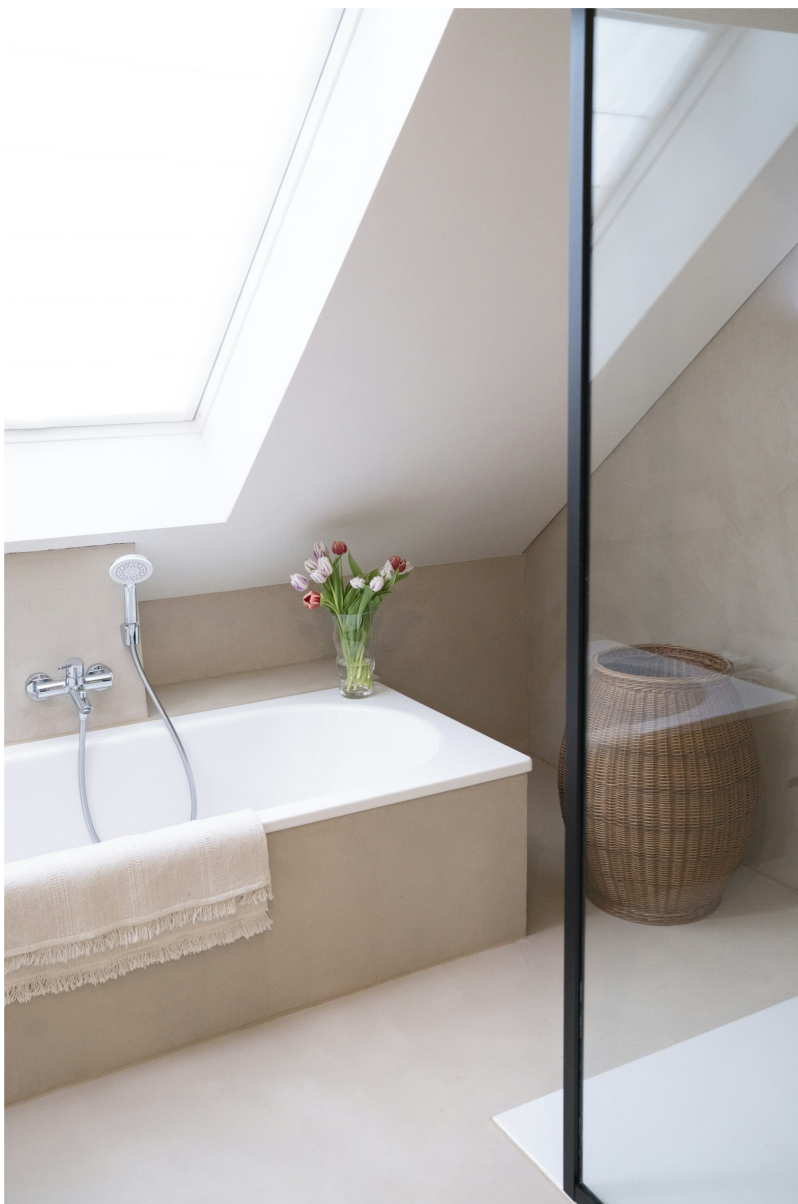
The bathroom has a bath with shower over, basin and WC. Sealants around the bath were in satisfactory condition.

*Bathroom*
